Reinforced Concrete Structures in “Saline Environment”

- By Dipl.-Ing. Reinhard Damm -

Infoletter
Issue No. 1

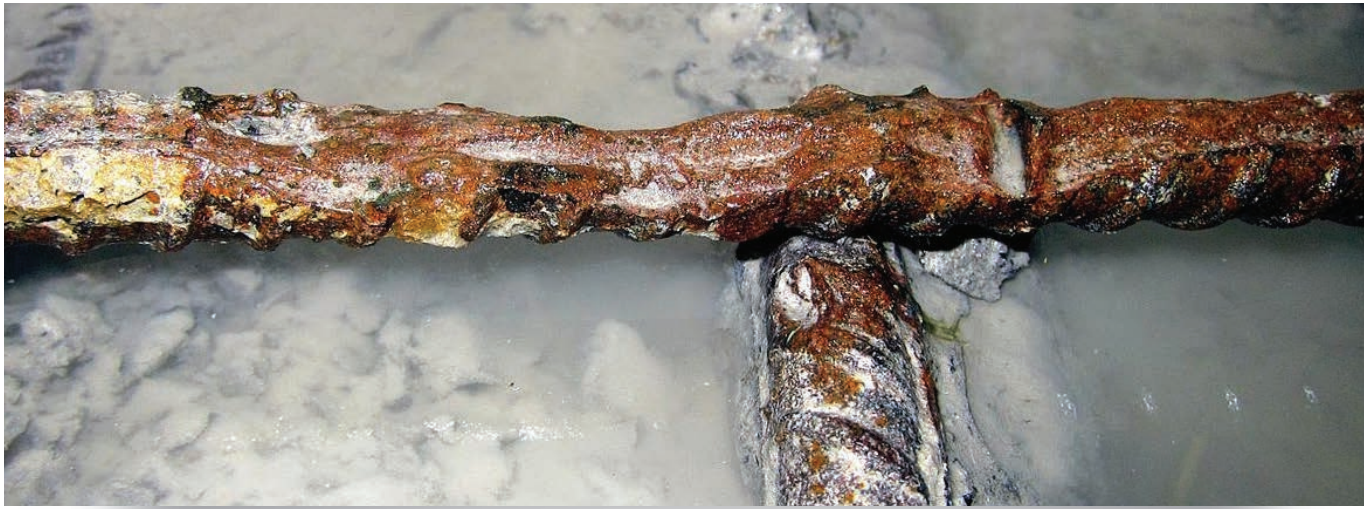
Fig. 1: Cross section reduced by corrosion

Obviously the corrosion process has an impact on the strength of the reinforcement by reducing the cross section of the reinforcing bar. The cross section area is often in direct relation to the load capacity of the structural member.

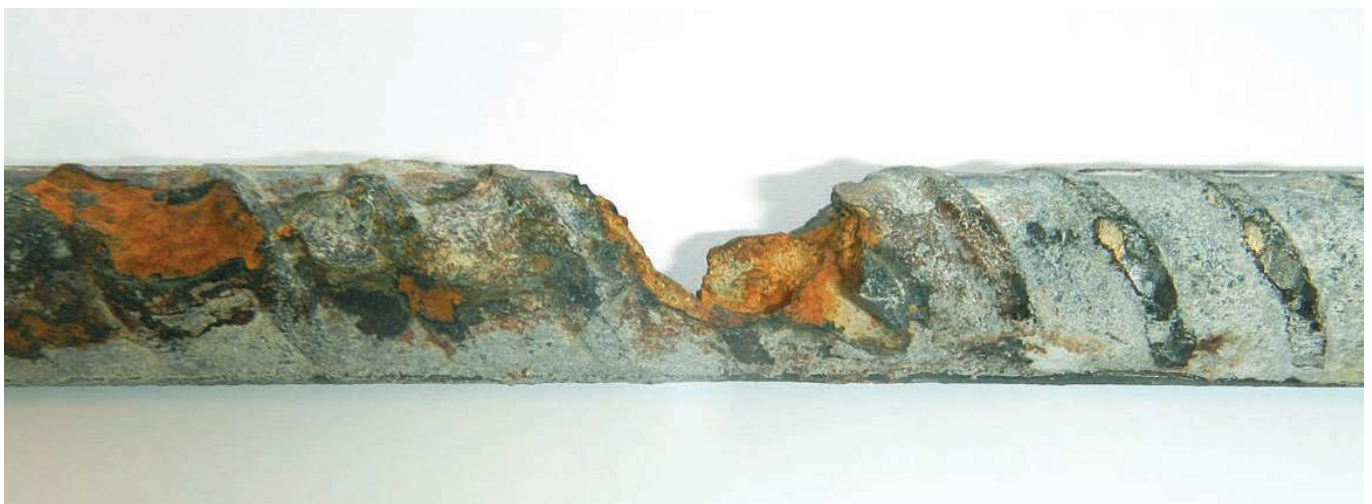
Fig. 2: Typical pitting corrosion

But there is also another form of corrosion which frequently occurs when chlorides, e. g. from sea water, are involved in the corrosion process. The chloride induced pitting corrosion tends to focus on small spots.

Pitting corrosion can progress extremely fast. Cases have been reported where 12mm diameter reinforcement corroded through within six months. Ironically the chemical reaction taking place in such corroding spots is protecting larger areas of the same piece of steel from corrosion by releasing electrons into the steel. The bar diameter does not increase and no damage is visible at the surface.

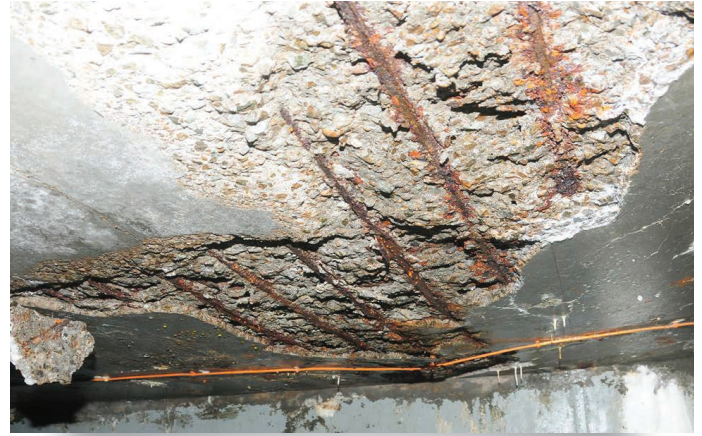
Fig. 4: Corrosion damage at floor slab

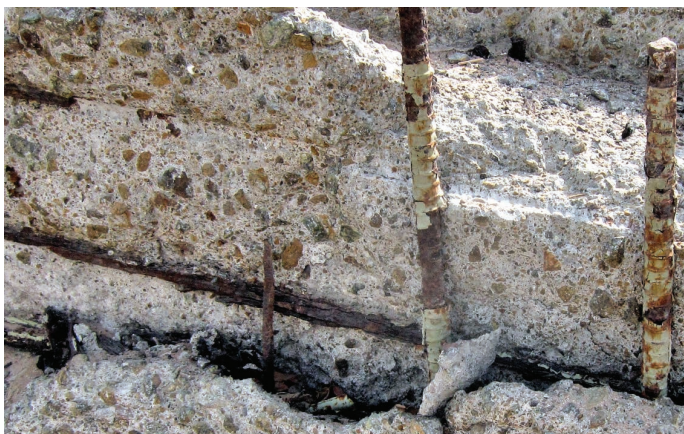
Fig. 5: Corrosion on coated reinforcing steel at a quay wall

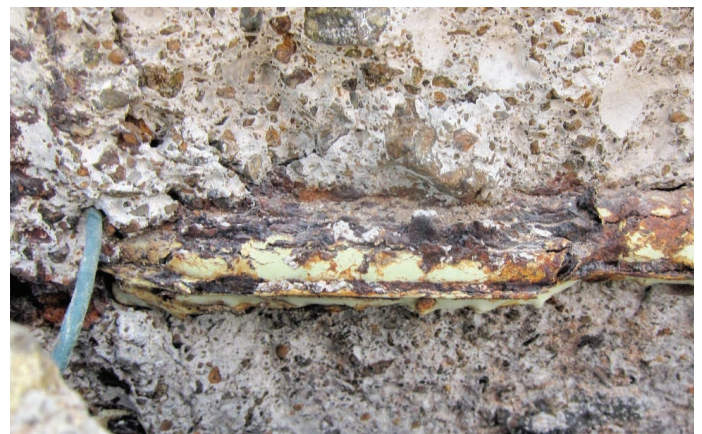
Fig. 6: Corrosion on coated reinforcing steel

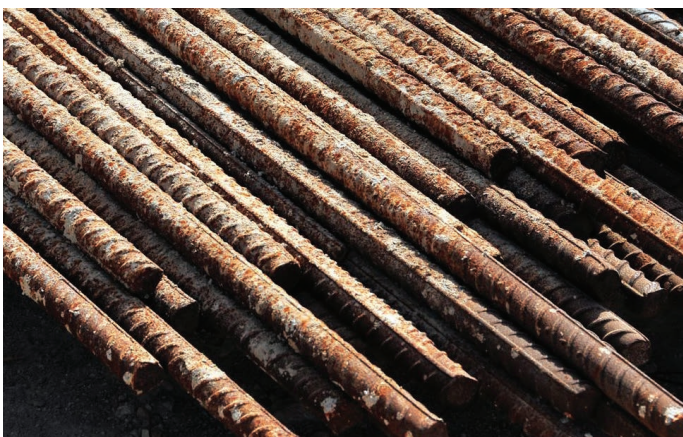
Fig. 7: Contaminated reinforcement

Concrete and steel may already get contaminated during construction. Examples of common sources of this are: contaminated or insufficiently desalinated mixing water, salty aggregate, reinforcing steel that has been stored on salty ground without protection, salt carried to slab reinforcement by workers walking on salty ground, salty curing water or salty ground water in flooded construction pits.
